# HOLLY HALL BARN

## PRESENTATION BOARD 01

**Location:** Sandhoe, Northumberland  
**Approximate Projects Cost:** 500k  
**Architect:** JDDK Architects  
**Project Technologist:** Tristan Cooper MCIAT  
**Year Completed:** 2022  
**Structural Engineer:** Fairhurst  
**M&E Engineer:** Armstrong Rhead

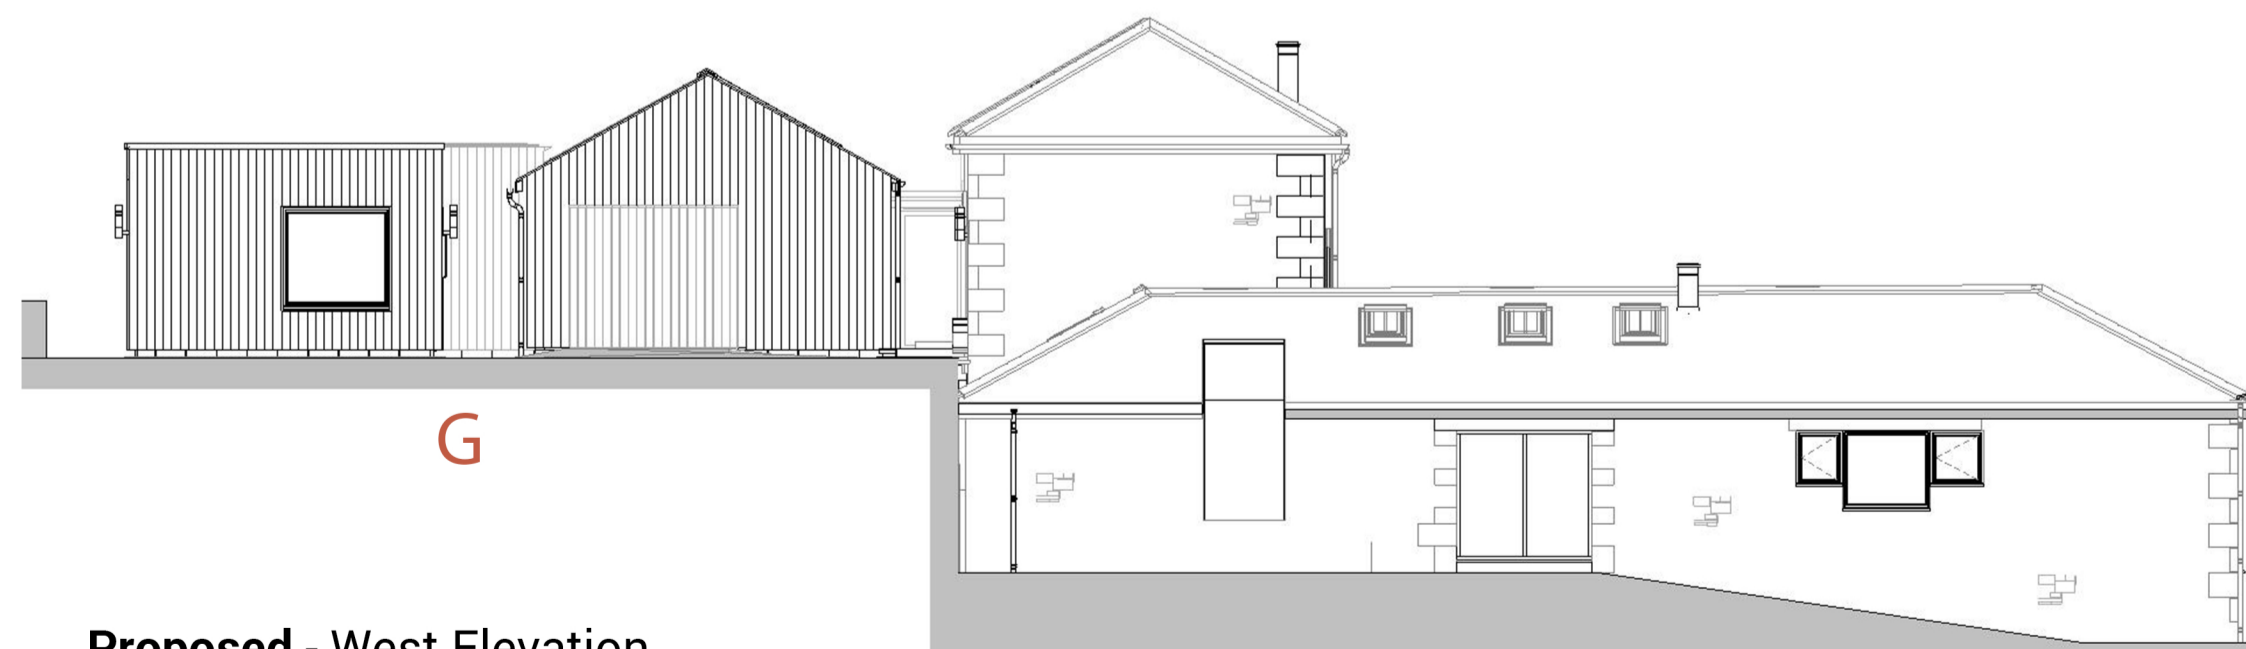
Proposed - West Elevation

In the living area within the west single storey portion of the building, we created a new opening in the existing stone wall on the West elevation to allow installation of a new bi-fold door. A new stove was installed in this location too. The existing bathroom in the part of the building was opened up into the store and a new ensuite was created.

New triple glazed composite windows and doors were installed to the west elevation where wind infiltration was an issue, new triple glazed internorm sliding doors were also installed to the long living room. High performance timber composite double glazed windows were installed everywhere else.

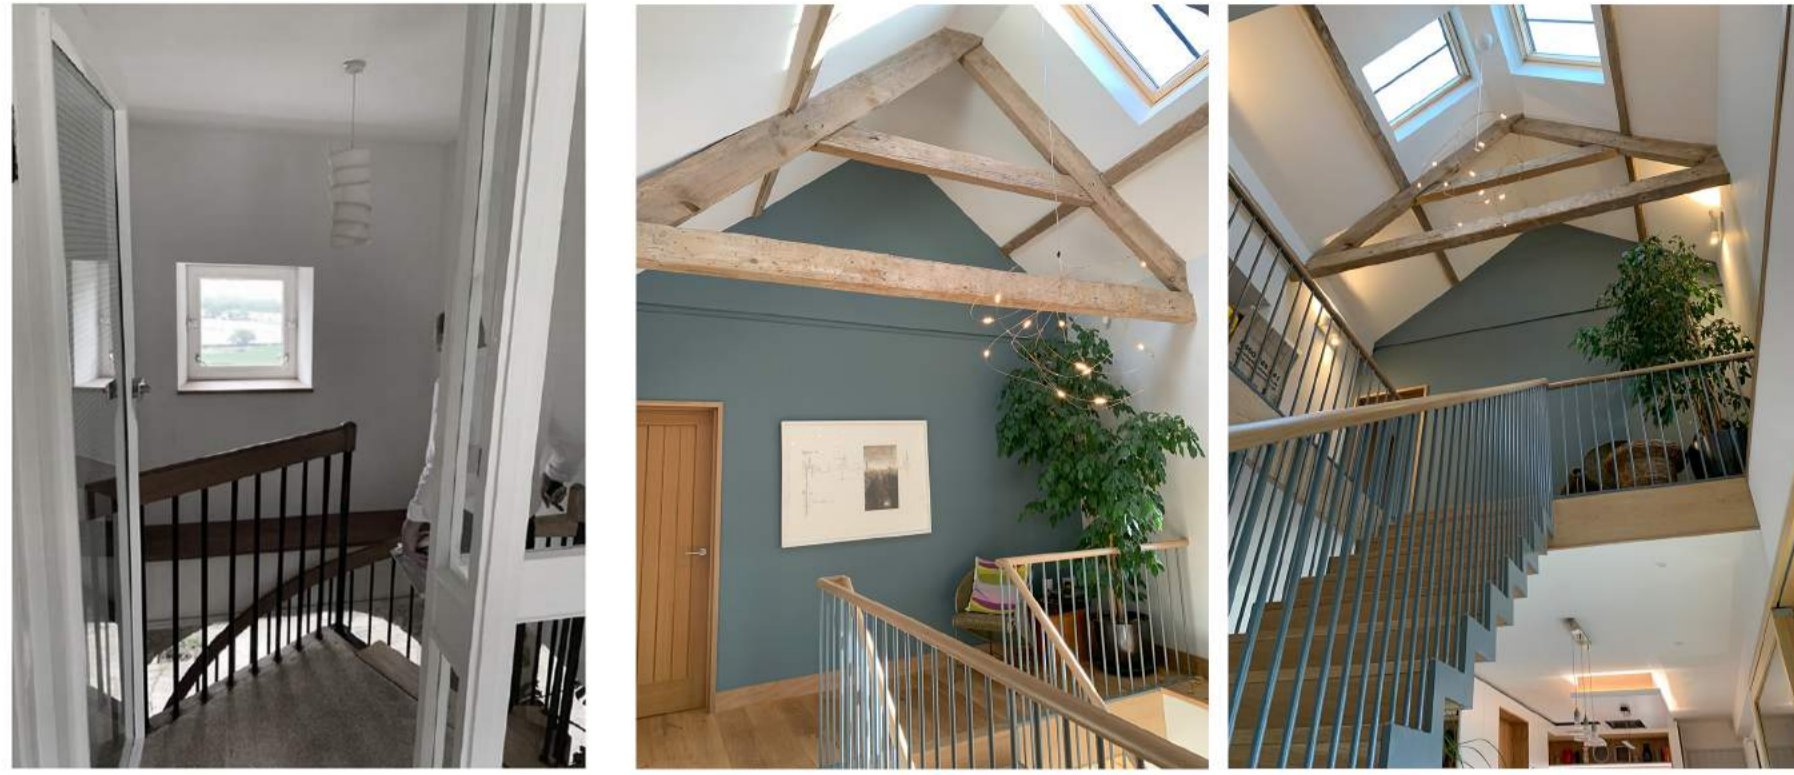
**Existing - Entrance Hall**      **New - Entrance Hall**

Entrance Hall and Staircase - The existing hall was removed, the spiral staircase was removed and the floor was opened up to accommodate the new staircase. The flat ceiling was removed and the existing trusses and purlins were exposed, the sloping ceiling was insulated and 2no. new roof lights were installed.

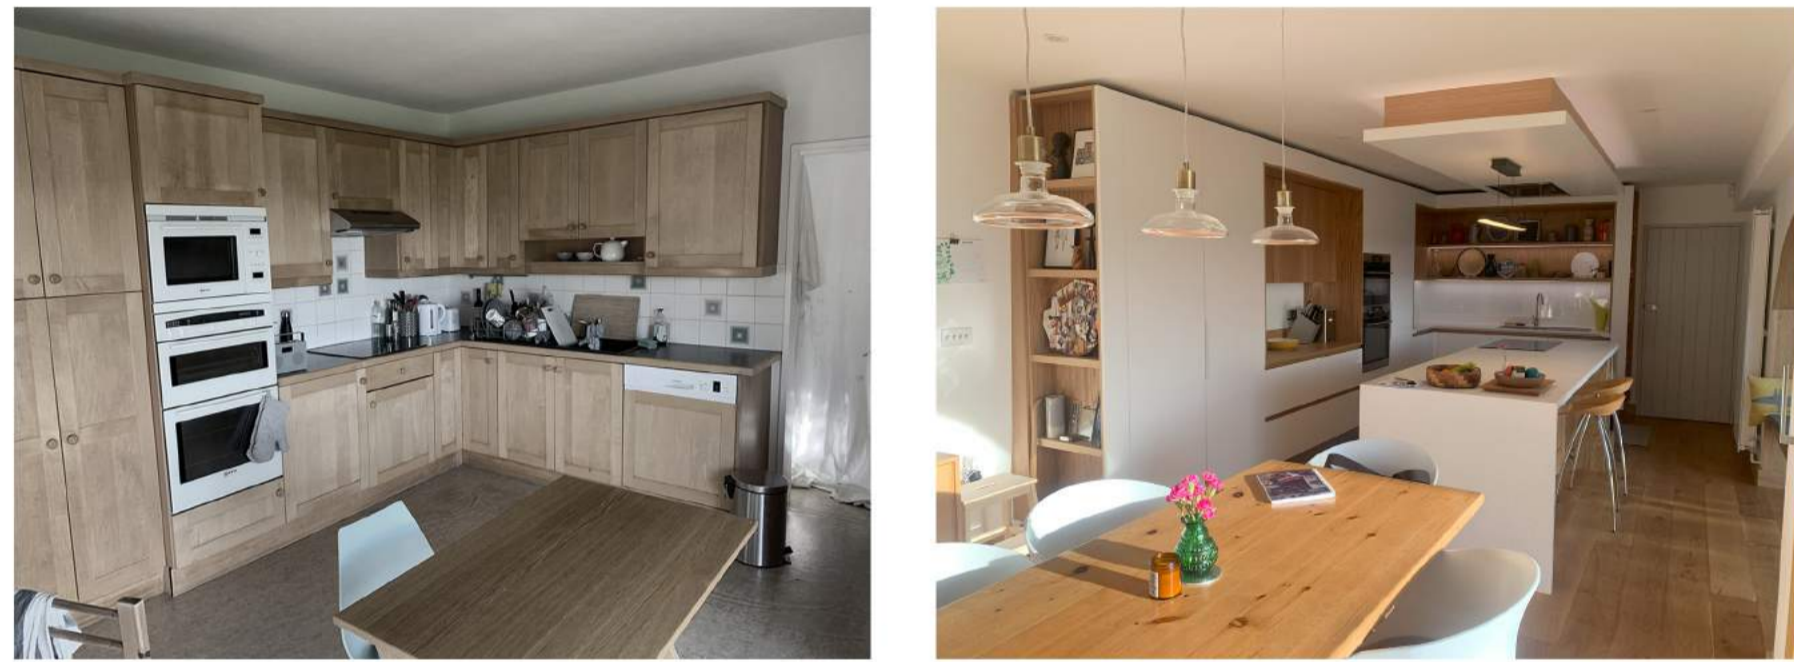
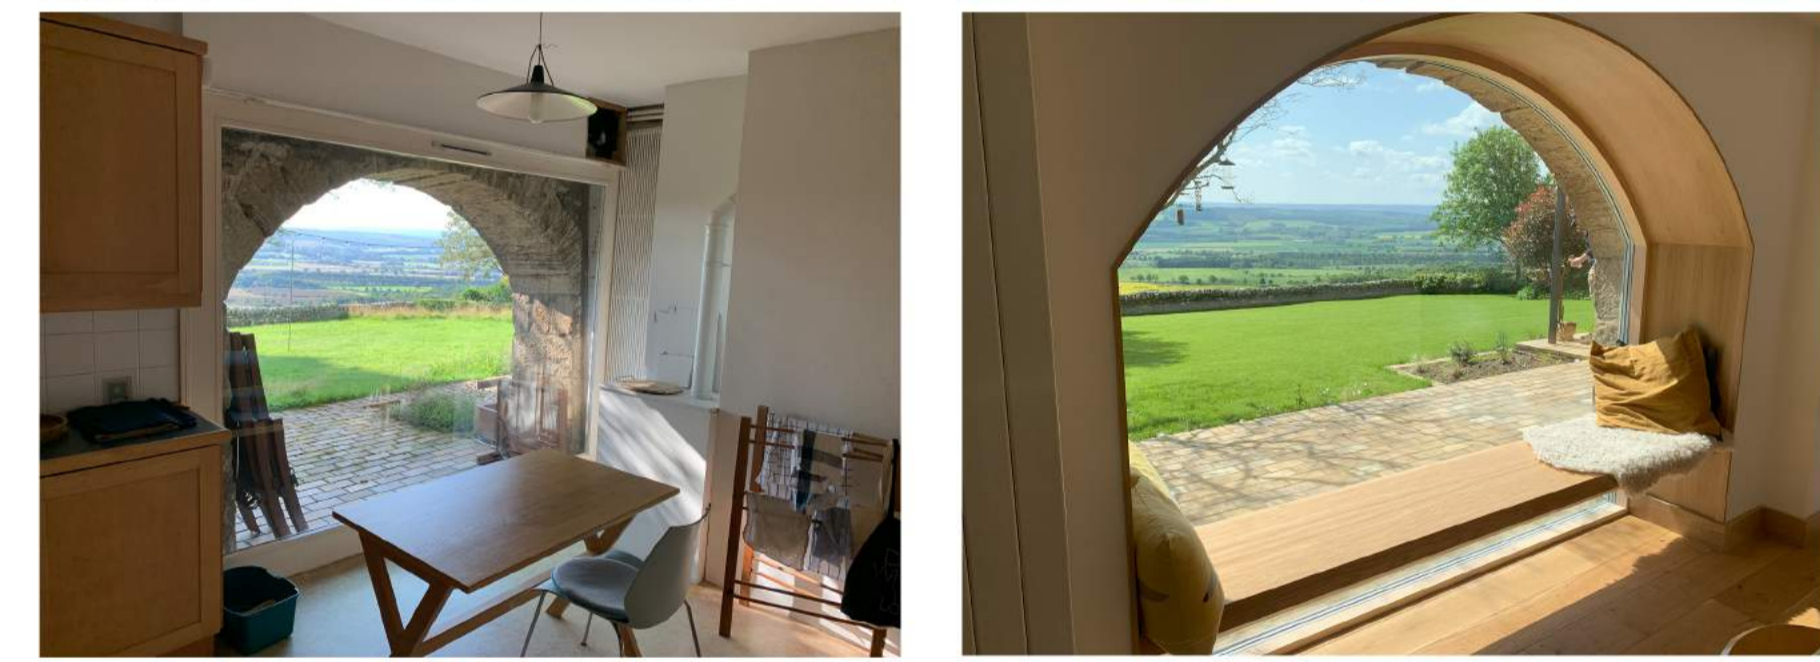
**Existing - Kitchen**      **New - Kitchen**

The existing load bearing partition between the existing kitchen and dining rooms was demolished which opened up the kitchen space. A new kitchen was installed. A new arched window with a clear spanning oak seat was installed in the existing arch and the cheeks were lined with oak.

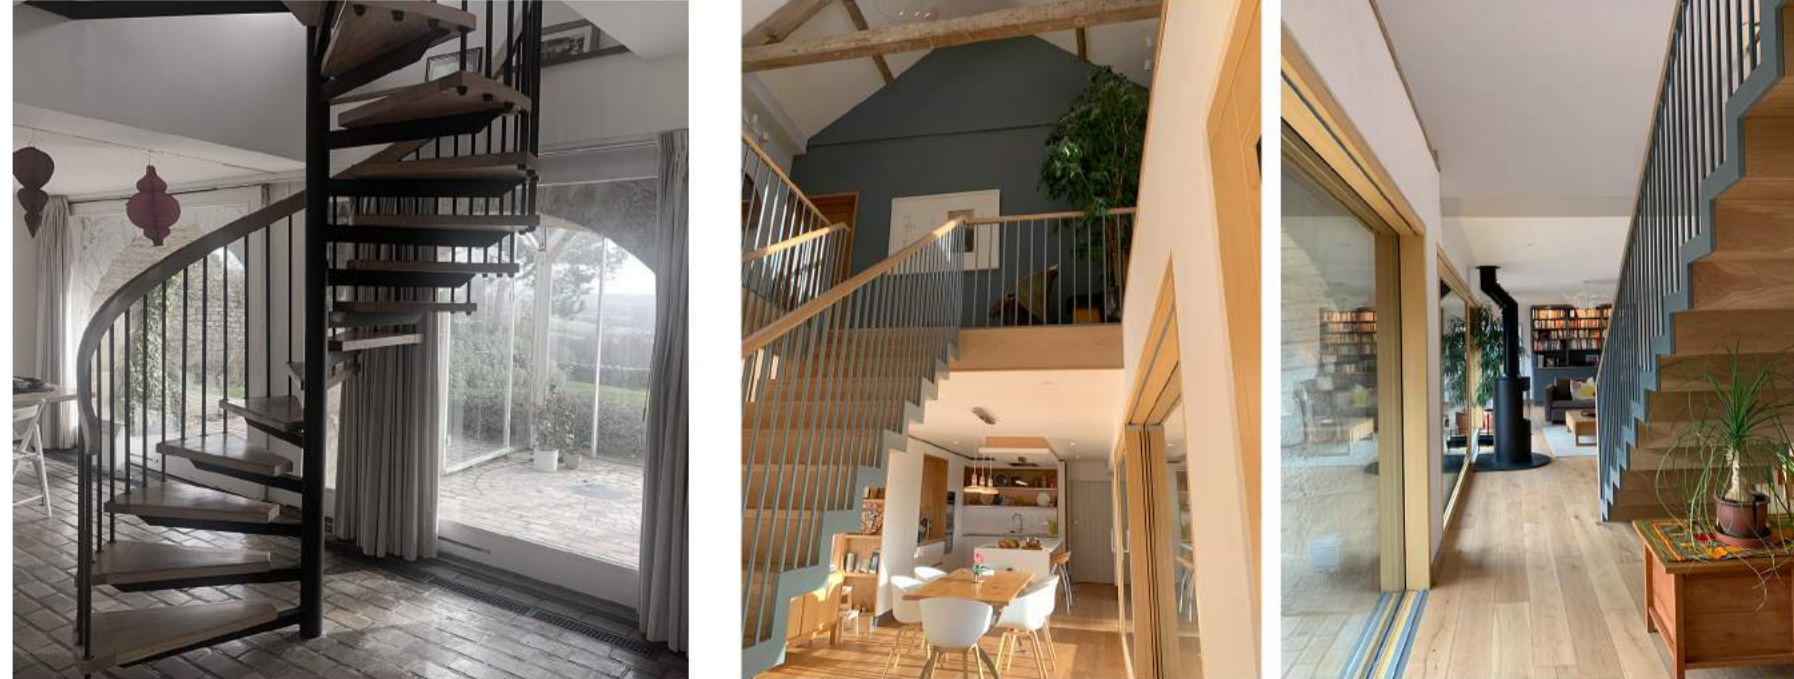
**Existing - Staircase**      **New - Staircase**

The original spiral staircase was removed and in its place we installed a clear spanning 'zig zag' staircase. The staircase was centred in the room and help delineate between the living room and the dining room.

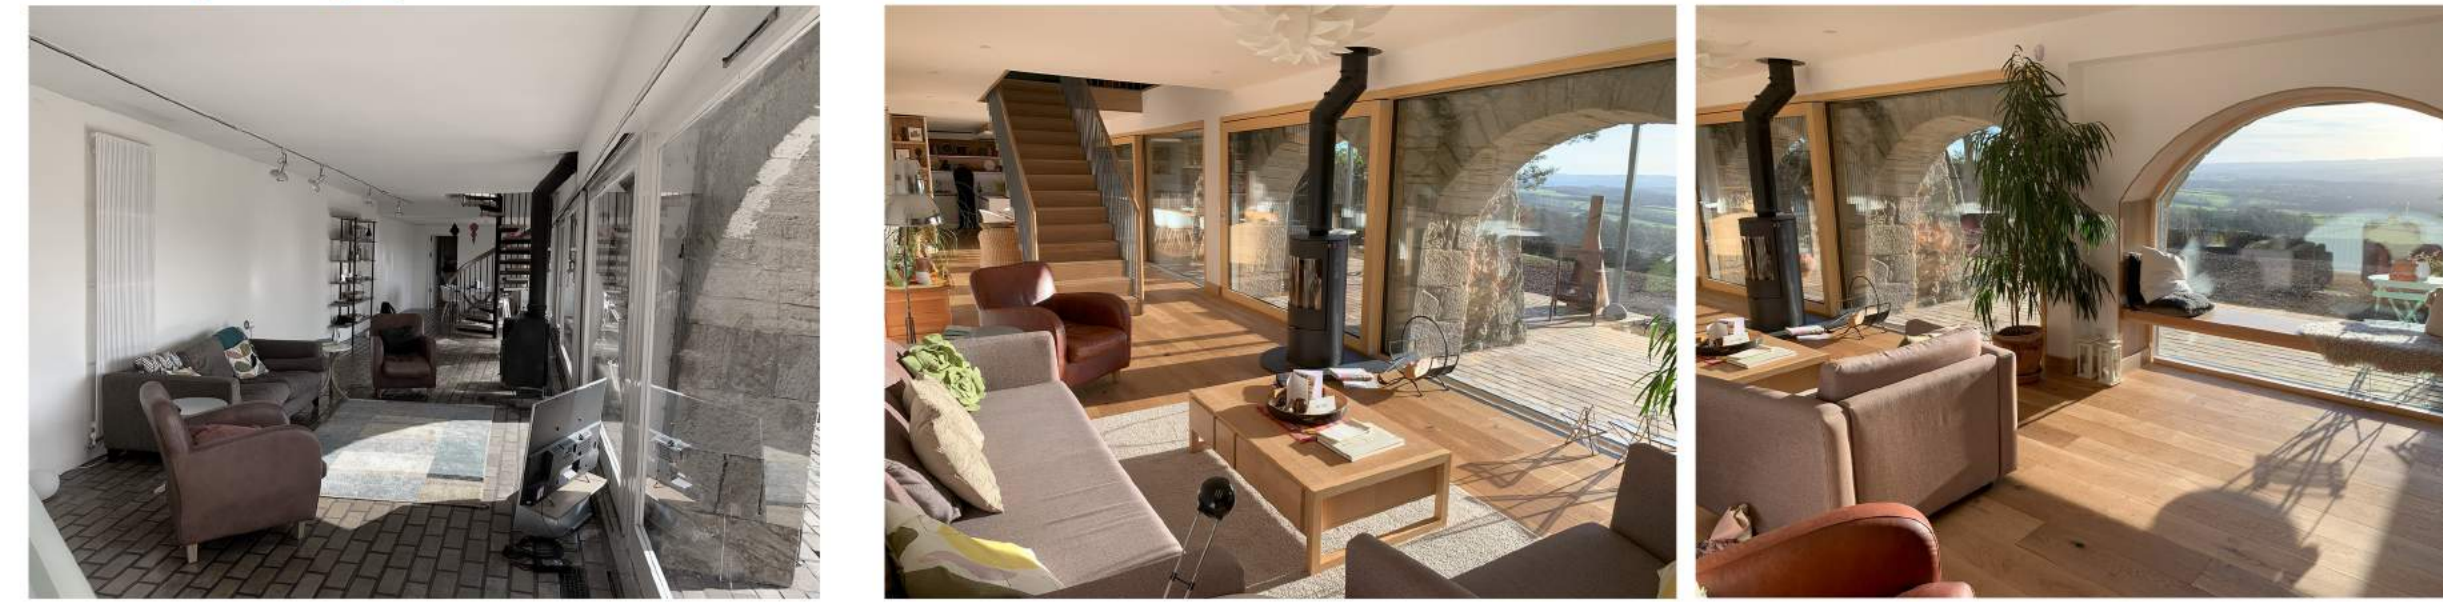
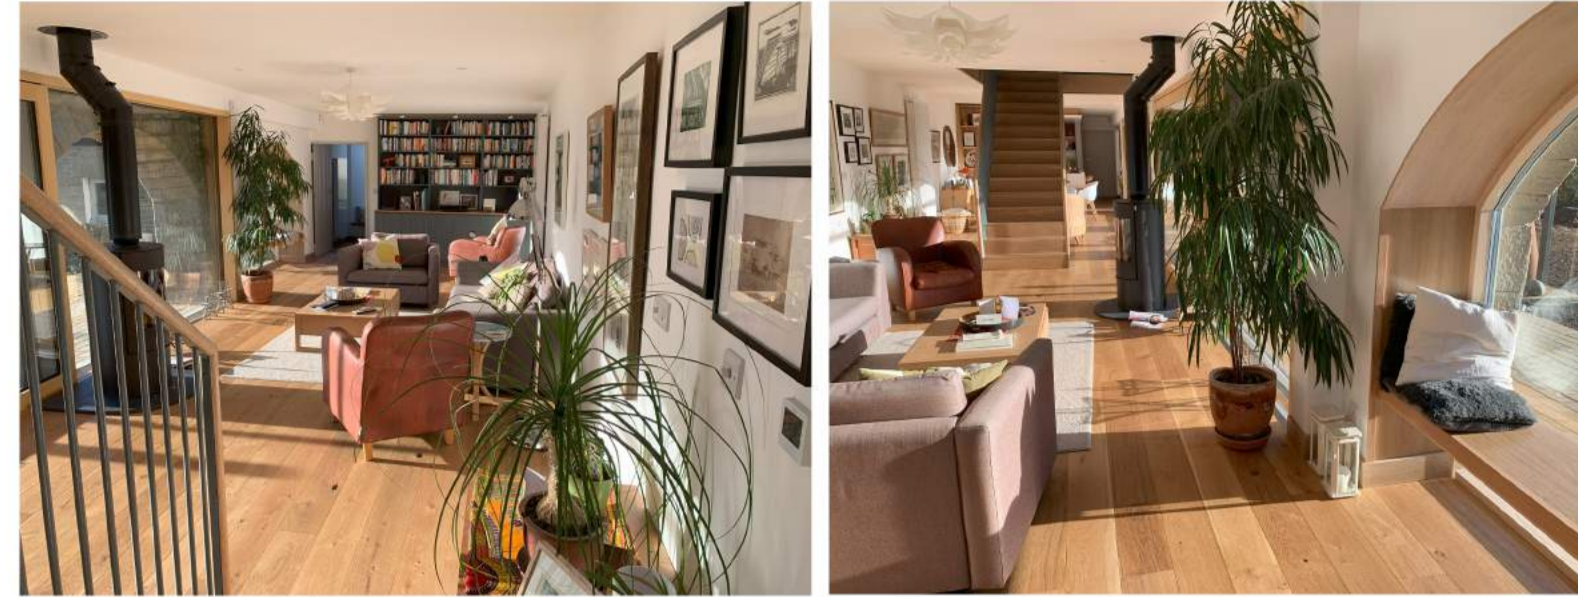
**Existing - Long Living Space**

The long room was stripped right back to stone and insulated where possible while maintaining breathability.

The first floor joist were repaired where needed and a new opening was created within the ceiling for the staircase. New timber framing was formed around the arches to support the new glazed sliding doors and new electrics and plumbing were installed.

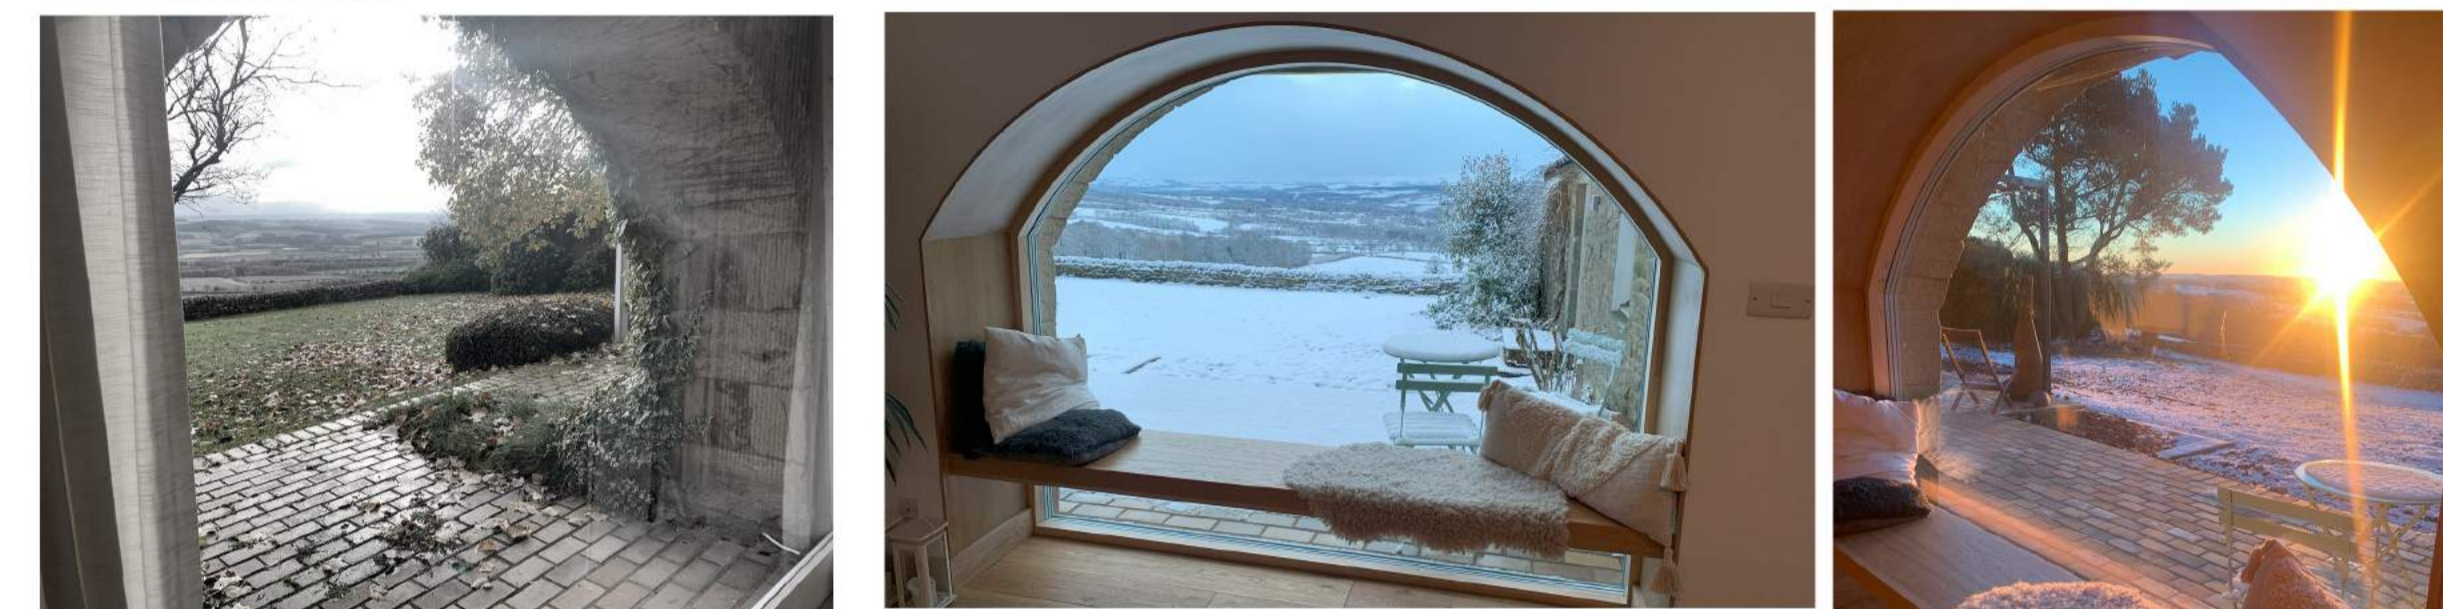
**New - Arched Window and Seat**

The existing window which sat within the living room was removed and replaced with a fixed, arched double glazed window. The stone cheeks were insulated at the jambs with aerogel to provide a better surface temperature factor and then wrapped with a flexible oak veneer plywood. The bench clear spans the stone cheeks which was achieved by installing steel 2no. RHS bearing onto steel angle brackets.

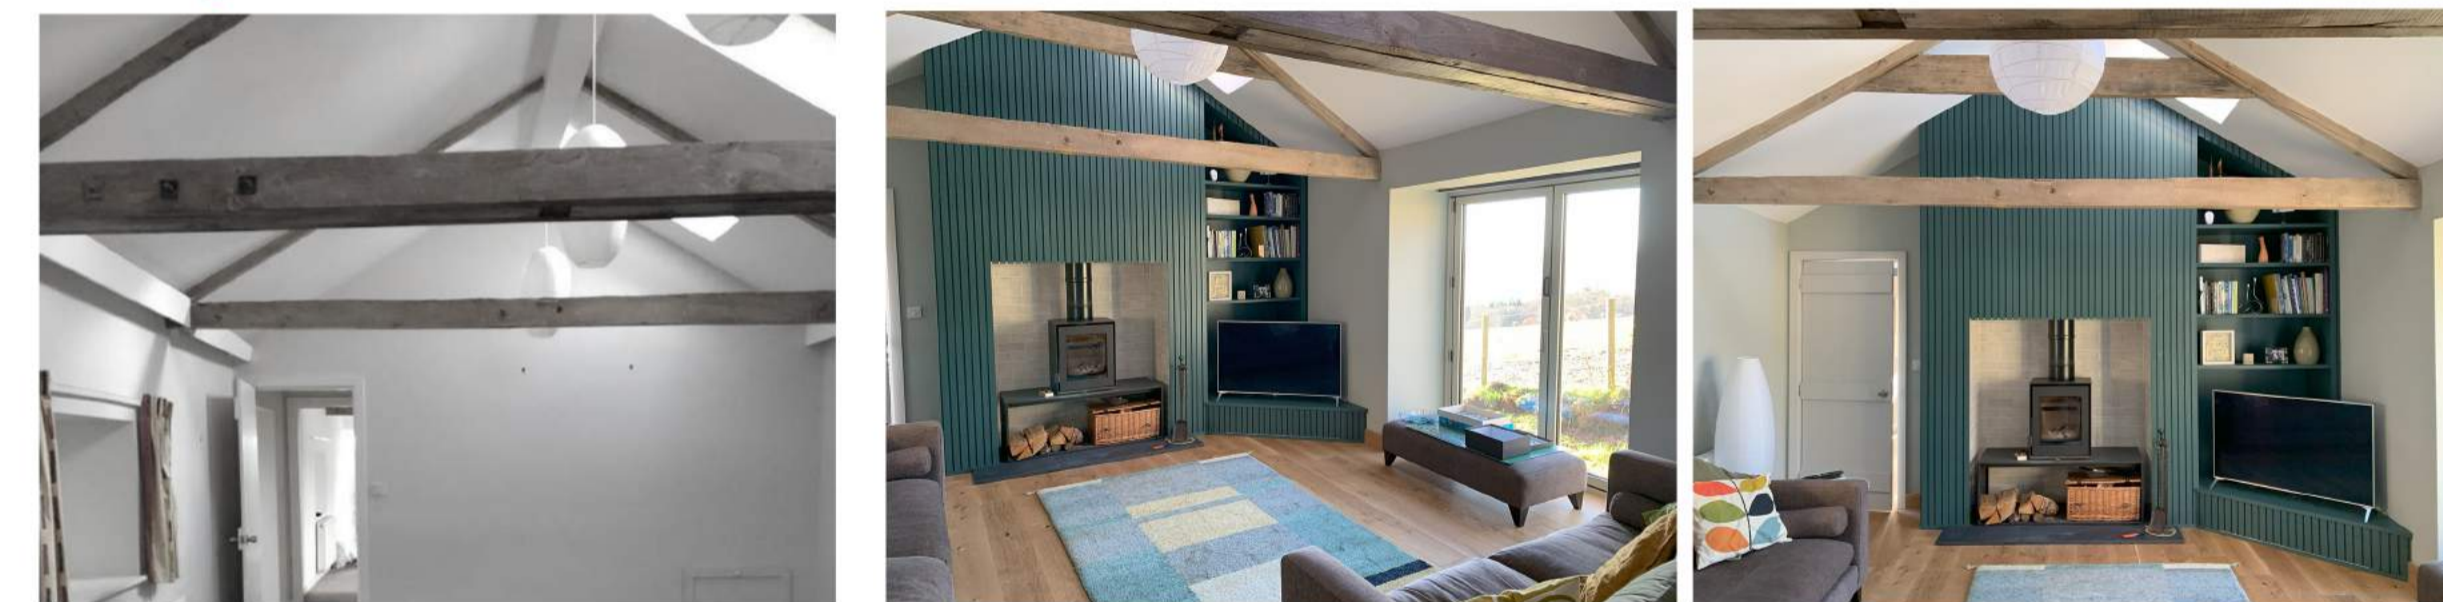
**New - Living Room**

In the living area within the west single storey portion of the building, we created a new opening in the existing stone wall on the West elevation to allow installation of a new bi-fold door. A new stove was installed with a site formed surround that accommodated the log store, book case and TV location. All the existing flooring was replaced with timber.

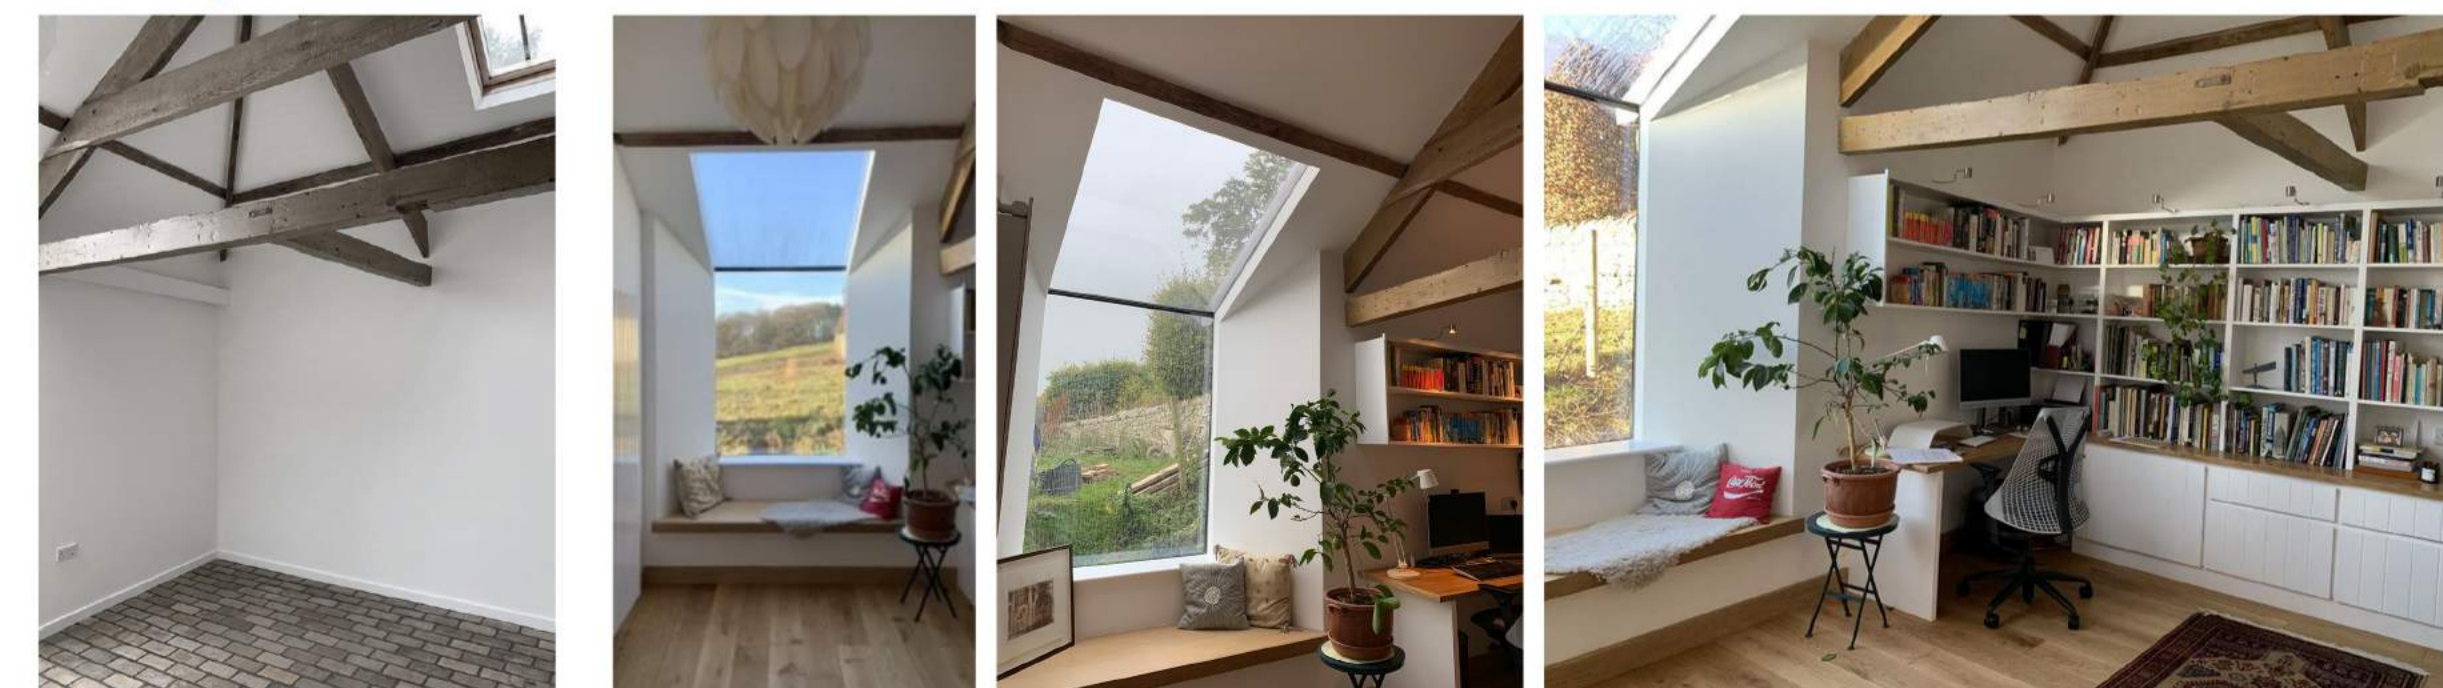
**New - Study / Music Room**

In the Study / Music room the floor existing floor was dug up and installation, screed and a new underfloor heating system was installed. The existing window was replaced with a new glazed eaves system.

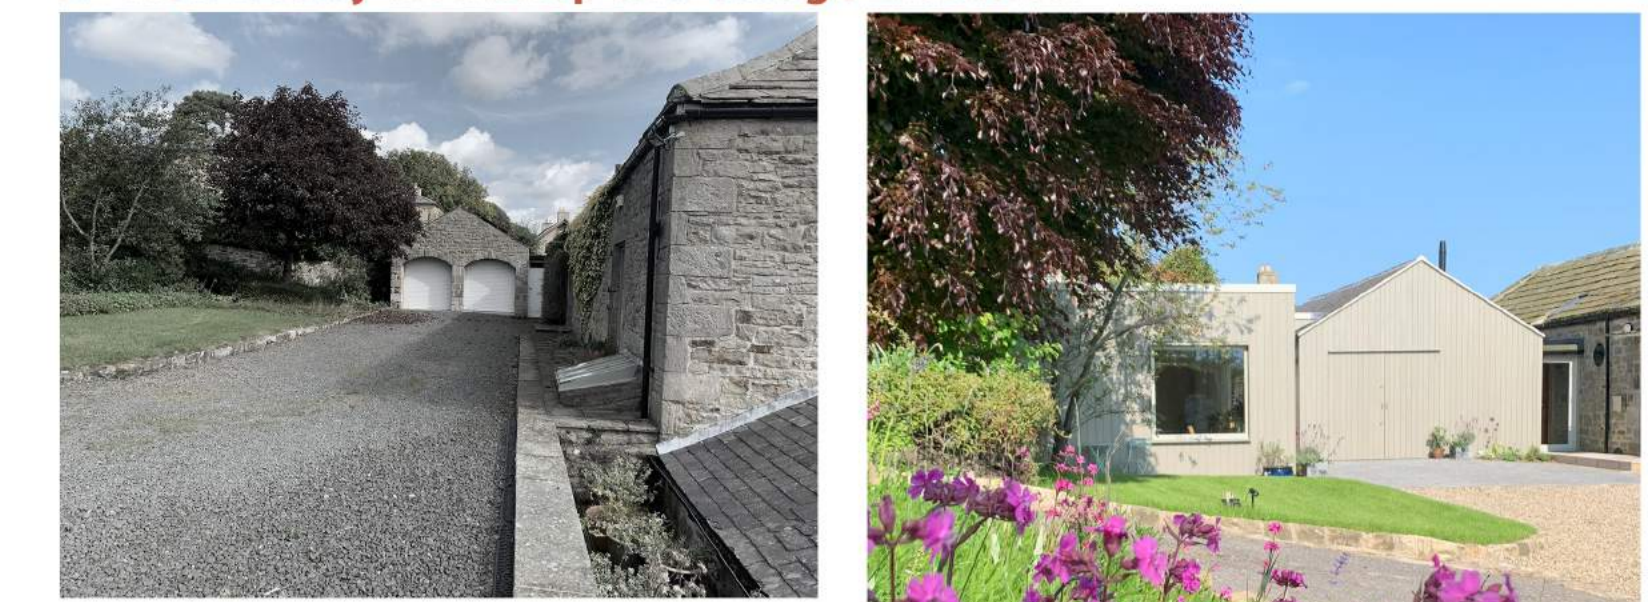
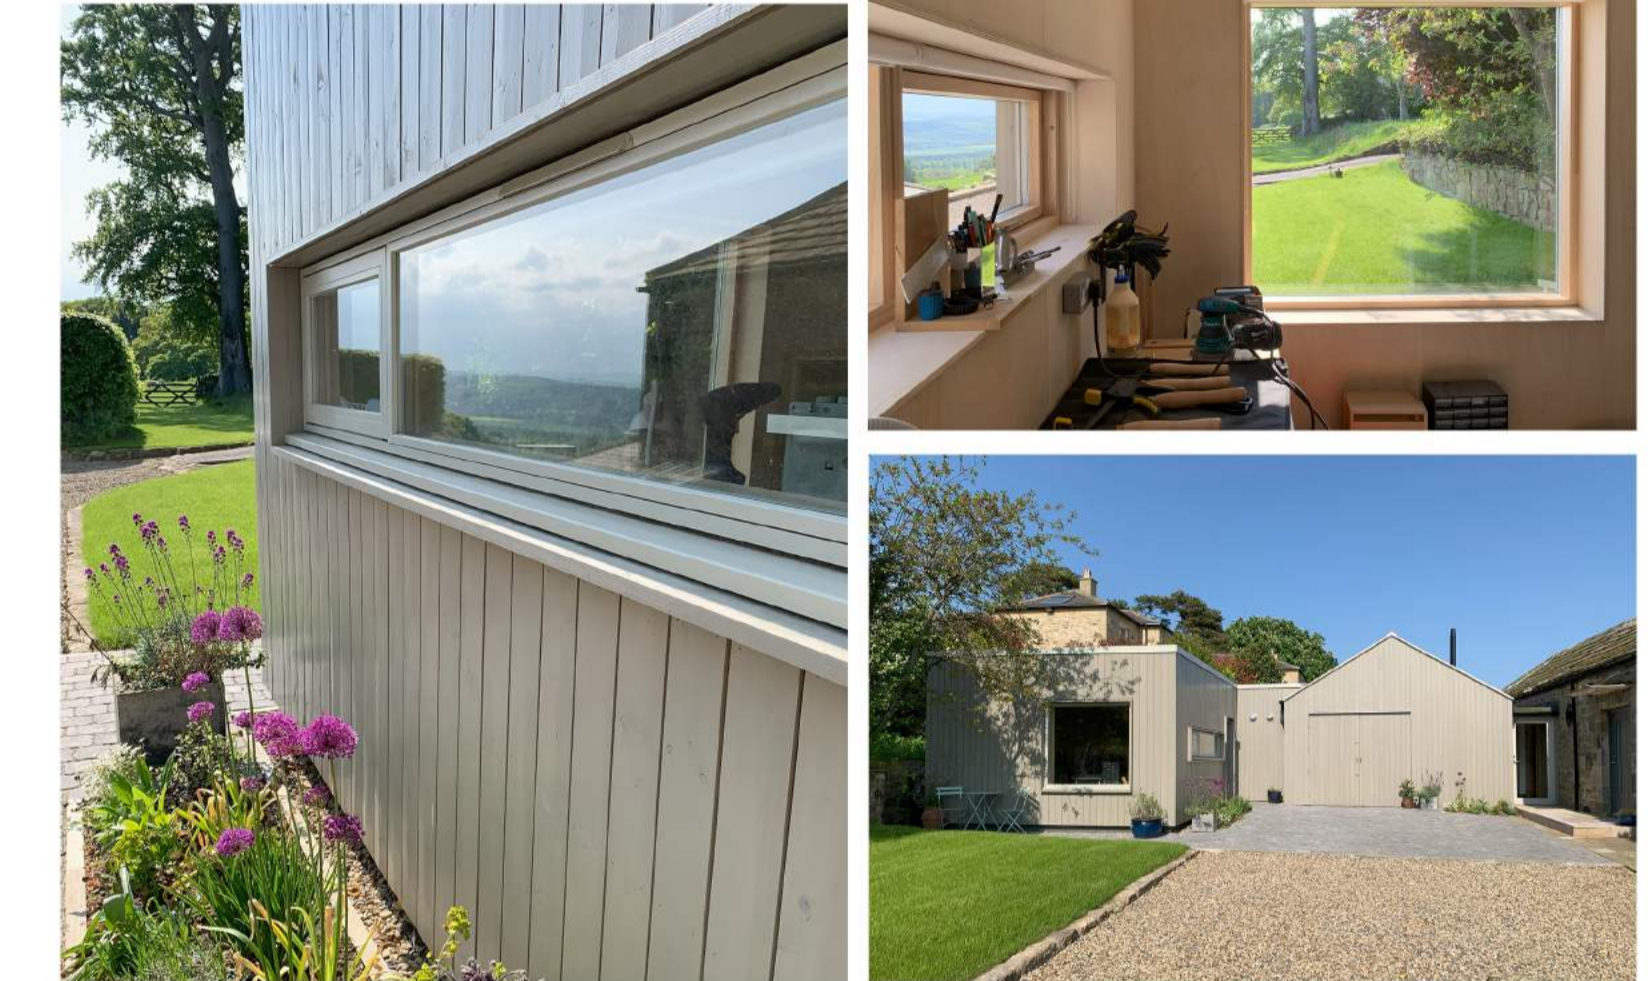
**New - Garage and Hobby Workshop**

A new side door would be installed next to the garage, the existing garage was enlarged by extending it forward, and a wood pellet store was installed between the garage and the new hobby workshop.

A new hobby workshop was to be built next to the existing garage, this was designed as a timber frame construction with timber cladding, and a sedum green roof.

The new hobby workshop is built from an 140mm insulated timber frame with 40mm isolair insulation to the inside preventing thermal bridging. The U-value achieves 0.2W/m2.K which allows for 12% repeating timbers in the 140mm insulation layer.

The warm roof is made up of 250mm Bauder PIR insulation on a plywood deck. Green roof vegetation layer is installed on top of the insulation. The U-value achieved is 0.12W/m2.K

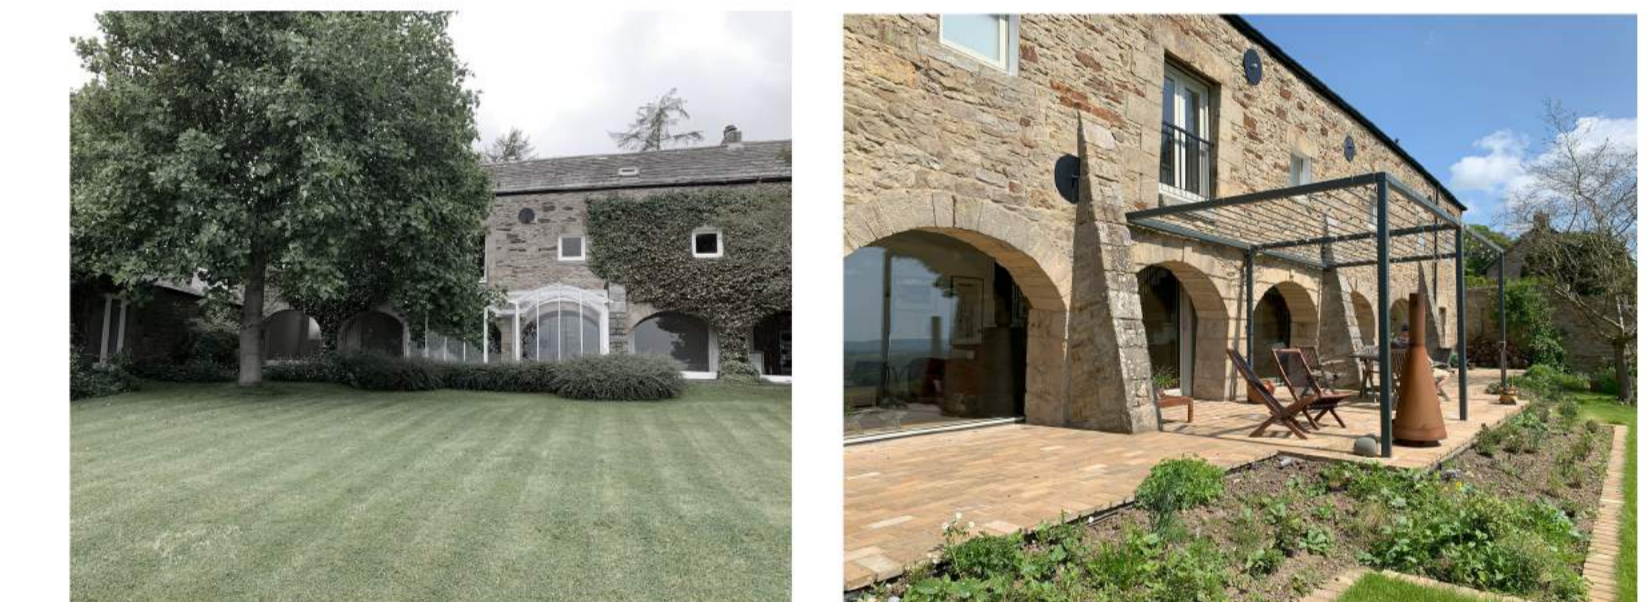
**New - South Garden**

On the upper level a new gravel drive was installed with new paving laid around the workshop, pellet store and garage. On the lower level the existing conservatory was to be demolished and a new installed pergola in its place. A new patio was detailed and laid using the original clay paviours.
